## **Cases of Slope Failure of Irrigation And Drainage Channels In Egypt and Their Rehabilitation**

Sherif M. Elkholy<sup>1</sup>

### **Abstract**

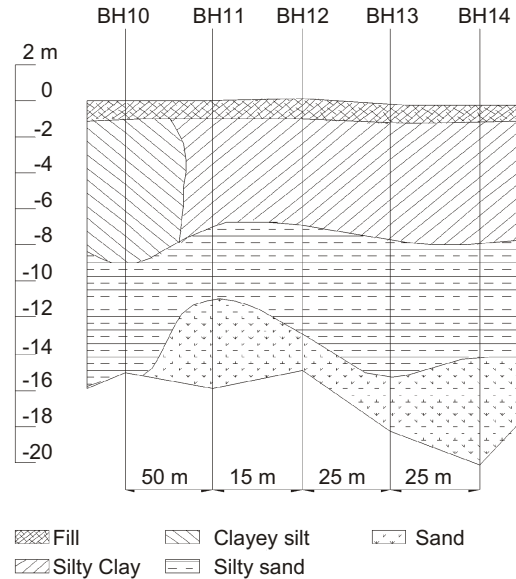
Figure 2 : Soil profile of case 4

A complete geotechnical study of the site was carried out including drilling 20 boreholes with a depth between 15.0 m to 20.0 m and disturbed and undisturbed samples were collected. Furthermore, field and laboratory tests in order to determine the physical and engineering properties of the soil deposits in the site were carried out. The results of the field and laboratory tests showed that the soil stratification in the site consists of a surface soil layer with a thickness of 1.0 m followed by about 7.0 m of medium stiff silty clay with traces of lime. Then, a layer of silty fine sand with a thickness of about 7.0 m exists, followed by a fine sand layer with a thickness of about 5.0 m. Figure 2 shows the soil profile of case 4.

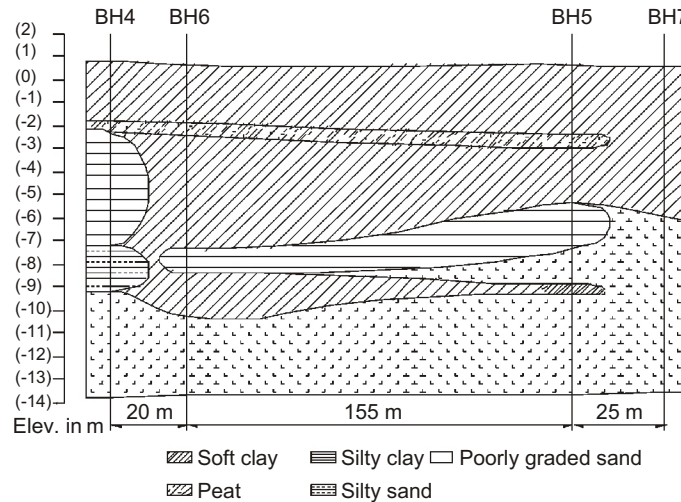
Figure 3 : Soil profile of case 5

The boreholes showed that the soil deposit consisted mainly of two layers. The first one is highly plastic soft silty clay layer that extends to a depth ranging from 6.5 m to 8.0 m. The second one is poorly graded sand that extends to the

end of the borehole. Alens of peat with a thickness ranging from 0.35 m to 0.60 m existed at a depth 3.00 m. Figure 3 shows the soil profile of this case. The value of the cohesion of the soft silty clay layer resulting from the field vane shear test ranged from 0.11 kg/cm<sup>2</sup> to 0.29 kg/cm<sup>2</sup> and its liquid limit ranged from 50% to 107%.

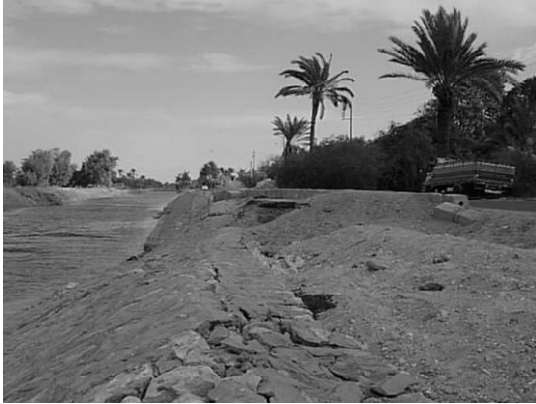
In this case, when examining the site history and condition, it was found that a main road was constructed on the left embankment of the canal to allow heavy traffic loads to pass along it. The construction process included completing the embankment width and reshaping the side slope to its original slope 2:1 and then put riprap to protect it. It was also known that a bomb hit the site during 1973 war. Consequently, the site investigation was directed to investigate the presence of a camouflets which is an underground cavity formed by the explosion of a bomb without the formation of a crater (British Standards Institution, 1957). Not finding any cavity, a slope stability study of the left embankment was conducted. An equivalent load of a 60-ton lorry and the case of sudden draw down of the water level in the canal were considered. The critical factor of safety was almost 1.0 and the sliding circle lied inside the loose surface soil layer. This value of the factor of safety is low and explains the repeated failure of the left embankment and the riprap on the side slopes. When using a slope of 2.5:1 and the properties of dense soil in the stability analysis, the critical factor of safety became 1.48, which is accepted according to the Egyptian code. Hence, it was concluded that the explosion at the site caused the top sandy soil to loosen along the failing 100.0 m reach. Then, after constructing the main road, the loose nature of the top soil layer could not stand the new heavy traffic loads causing the repeated slope failures. Figure 4 shows the slope failure of the embankment.

Figure 4 : Slope failure of case 1

In this case, the slope stability study showed that the side slope 2:1 is not suitable and that changing it to 2.5:1 and compacting the soil mass of the slope would satisfy the requirements of the Egyptian code of practice. However, the restriction imposed in this case is the impossibility of changing the side slopes in this reach. Therefore, it was suggested to use a supporting system for the embankment as an alternative solution. This supporting system

consisted of reinforced concrete piles with a diameter of 60 cm and a center-to-center space of 1.50 m. The factor of safety of the stabilized embankment was 1.96 and the sliding circle was a base circle. It was recommended to use partial displacement piles, to improve the density of the loose layer, with a depth of 15.0 m and the length of the stabilized reach extended for 20.0 m from both sides of the failing reach of the embankment. A reinforced concrete beam with a width of 70 cm and a depth of 60 cm was used to connect the piles together. Then, the slopes should be dressed to the original slope 2:1 and the riprap replaced with a thickness of 40.0 cm. The details of the rehabilitation technique are shown in Figure 8.

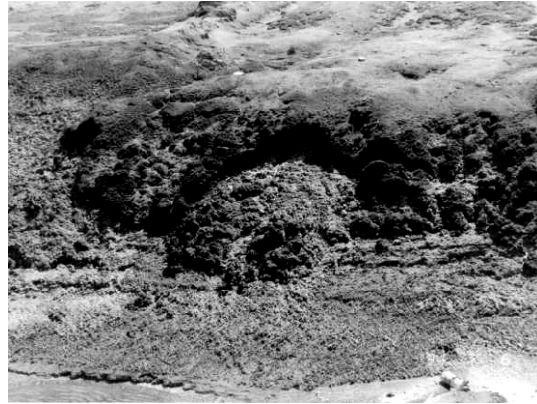
Figure 5 : Salt leaching and slope failure of case 2

Stability analysis of the slopes of the channel and drain was carried out to identify the main cause of the slope failure. This study was carried out under different boundary conditions such as with and without seepage effect, with and without sudden draw down of the water level in the channel, and with and without live load on the embankment. In all cases, the factor of safety achieved the requirements of the Egyptian code of practice. Therefore, the existing slope failure cannot be attributed to any of the above-mentioned conditions. Looking at the laboratory test results, it was noted that the chemical analysis of the soil samples showed the presence of a high percentage of dissolved salts. Hence, the attention was drawn to the results of the chemical analysis of the soil and the water and it was concluded that the failure occurred because of the leaching effect of the high salt concentration within the soil particles and consequently initiating the piping phenomenon (internal erosion). Figure 5 shows salt traces due to leaching at the drain side slopes. The developed seepage forces started the fine particles washing (migration) and that in turn reduced the stability of the drain side slopes and consequently causing the slope failure of the drain. Furthermore, the continuing process of internal erosion created cavities within the soil mass between the canal and drain causing collapse of parts of the embankment surface and parts of the gabions on the canal side slopes. Field observations supported the above-mentioned conclusion of the cause of failure.

Since the problem in this case is mainly due to the seepage that causes salt leaching and consequently cavities, the rehabilitation aimed mainly at controlling the seepage line from the canal to the drain to reduce the values of the exit gradient and protect the soil mass against piping. This goal can be achieved using cutoff wall technique. Several schemes were attempted by changing the number of cutoffs, their positions, and their depths to reach the optimum cutoff solution. The amount of water seeping from the canal to the drain, as well as the values of the critical exit gradient were obtained for each case and the results were compared with the case of no cutoff. The case of inverse seepage from the drain to the canal was also studied to account for the canal maintenance at which the water level drops to almost zero. Based on the results, a system of two cutoff walls was suggested. The first cutoff is at the canal left berm with a depth of 6.0 m and the second one is at the drain right embankment with a depth of 14.0 m. Fig. 9 shows the general layout of the problem area and the suggested solution. Figure 10 shows the details of the protection filter to safeguard the soil mass against fine particle migration to minimize the internal erosion.

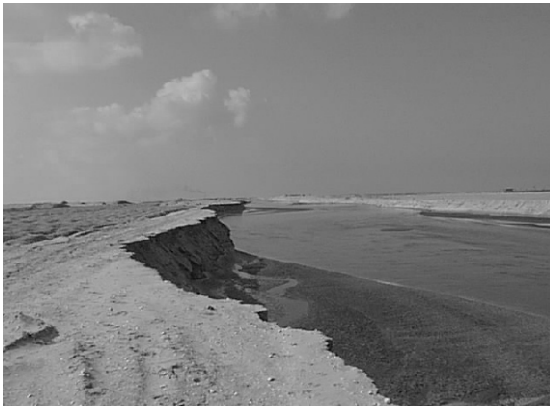
Examining the drain cross-sections, field observations, the site investigation data, and the laboratory test results, two major characteristics of this site were noticed. The first one is that the soil is poorly graded fine to medium sand as revealed from the grain size distribution of the soil samples. The poorly graded sand is hard to be compacted efficiently and as well known, the maximum stable slope angle for dry sand, under no external loads, is its angle of internal friction (Budhu and Gobin, 1996). If seepage or surface erosion is permitted through the sand mass of such drain, it will collapse ending up with a flatter slope. The second major characteristic of the site is that the water table in the neighboring agricultural land is quite higher than the water level in the drain with a difference that ranges from 1.40 m to 2.40 m. Such a difference caused high seepage forces on the drain side slopes. This in turn caused the sliding of the slope mass into the drain at different locations along the drain path as indicated in Figure 6. The failures were worse in the locations closer to the pump station because of the severity of the bed erosion and the higher values of the hydraulic exit gradient on the side slopes. Then, the failing mass was washed out by the flowing water causing the sedimentation of the soil particles inside the suction basin of the pump station.

A slope stability analysis was carried out using a computer program. In the beginning, the stability of the slopes on the dry condition was examined and the factor of safety was 1.1, which shows that the slope does not satisfy the requirements of the Egyptian code of practice. Then, additional runs were carried out with seepage forces and live loads and the factor of safety was 0.96. The failure of such case can be attributed to two main causes, the first one is the instability of the slope due to the gravitational effect and the seepage forces, which cause the fine particles to

migrate causing internal erosion. The second one is due to the high velocity of the flowing water that causes surface erosion either from the side slopes and/or the bed of the drain especially near the suction basin of the pump station.

Figure 6 : Slope failure of case 3

It was indicated when talking about the causes of this problem that the basic problems in this drain are the loose nature of the original soil and the big difference between the level of the water table in the agricultural lands and the water level in the drain. Therefore, the rehabilitation of this drain depends mainly on satisfying two requirements. The first one is to lay the original soil on a flat slope that will be stable under the working conditions of the drain i.e. with water flowing through the embankment under 2.40 m of hydraulic head. The second one is to put a filter on the original soil to stop the washing out of the fine particles of the original soil.

Hence, to satisfy the first requirement the original soil was laid on a side slope 4:1. The factor of safety for this case is 1.47, which satisfies the requirement of the Egyptian code of practice. Then, a soil filter made of three transition layers was laid to prevent the fine particles from being washed out and to reshape the cross section to its original side slope 2:1. The factor of stability of this case is 1.29, which is less than the requirements of the Egyptian code of practice. Therefore, the side slopes were altered to 2.5:1 with an intermediate berm at level (-1.50). The factor of safety for this cross section is 1.74, which is acceptable according to the Egyptian code. Figure 11 shows the details and dimensions of the suggested cross section.

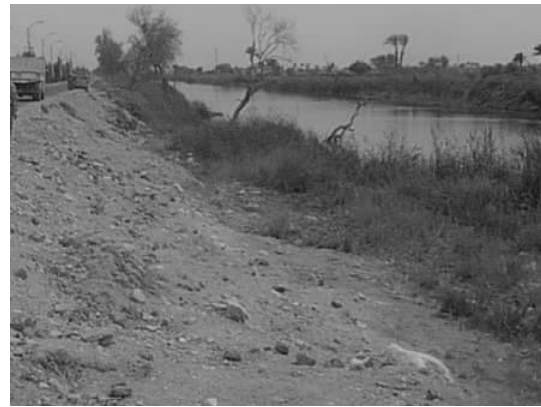
Figure 7 : Slope failure of case 4

Figure 7 shows the failure of the canal side slopes. A slope stability analysis was carried out to determine the probable causes of failure. Noting that the failures occurred after the winter closure, a sudden draw down of the water level was considered in the analysis. Also, the case where the seepage line is from the existing drain to the canal was studied. In both cases, equivalent loads of 60-ton lorry have been taken into consideration since heavy traffic loads were allowed on the road on the canal embankment. The factor of safety of the normal working conditions (without heavy traffic loads and sudden draw down) is 1.50, which is safe according to the Egyptian code of practice. While the minimum factor of safety was 0.70 in the case of sudden draw down and heavy traffic loads. Therefore, it was concluded that the sudden draw down combined with the heavier traffic loads caused the slope failure of the canal.

It was stated in the discussion of the causes of failure of this channel that the sudden draw down in the water level combined with the heavier traffic loads caused the slope failure of the canal. Sudden draw down have two negative effects on the stability of the side slope. The first is the destabilizing seepage forces associated with it and the possibility of washing out the finer particles from the original soil. Because of that, the solution depended on flattening the slope of the original soil and then using a filter on it to protect the fine particles. In this case, the slope of the original soil was made 4:1 and then a two-layer filter was laid. Then a gravelly sand soil was used to reshape the canal side slopes to the original one i.e. 3:2 and finally riprap was used with a thickness of 50 cm to protect it. The factor of safety for rehabilitated cross section is 1.52. The details of the suggested cross section are shown in Figure 12. It was recommended that the solution would be executed on alternate sections; each one is 20.0 m long.

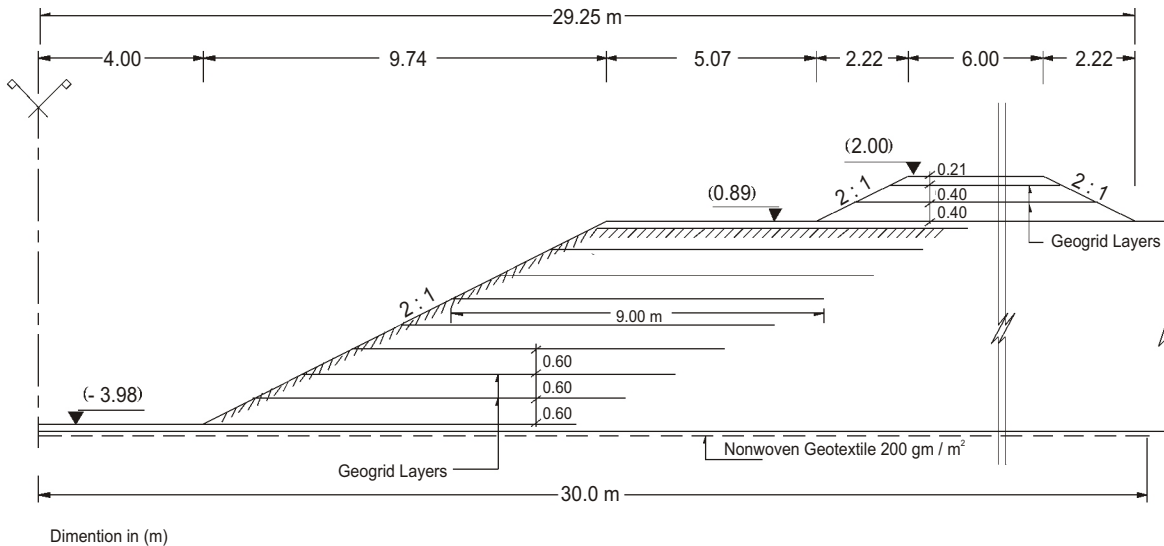
Figure 13 : The details of the rehabilitated cross-section of case 5.

Examining the results of the site investigation especially the field vane shear tests and the laboratory tests, it was clear that the cause of failure was the very weak nature of the soil deposits at the site especially the peat lenses in addition to the seepage from the neighboring agricultural land to the drain. Slope stability analysis of the drain cross section was conducted. The seepage from the neighboring agricultural lands was considered. The slip surface was forced to pass through the peat lens since it is much weaker than the surrounding soil deposits. The critical factor of safety was 0.69, which is quite lower than the requirements of the Egyptian code of practice.

The drain cross section was stabilized using earth reinforcement technique. The soil was reinforced using geogrid layers at a spacing of 0.60 m and a length of 9.0 m starting from the bed until the berm level. The peak strength of the geogrid is 30.0 KN/m and the yield point elongation is 10%. A single layer of geotextile was laid 0.30 m below the bed level starting from the drain centerline and extending under the embankment width. Silty sand soil was used to replace the natural soil of the site and was compacted accordingly on layers with a thickness of 0.30 m. Figure 13 shows the details of the solution.
