# Evaluation of Options for Remodelling of Upper Jhelum Canal, Pakistan

M. U. Rashid<sup>1</sup>, A. Latif<sup>2</sup>, U. Ghani<sup>3</sup>, M. Munir<sup>4</sup>, T. Sultan<sup>5</sup>

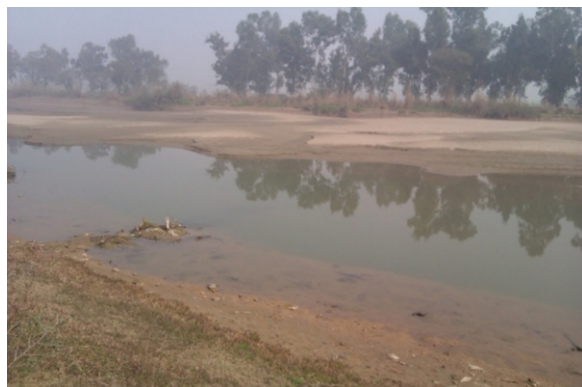
The channel bed was found slightly scoured in few head reaches up to RD 244+000. However, excessive silt deposition was observed through the entire reach of the channel from RD 244+000 to 418+000 (Tail). The silt deposition was measured at some locations and found in the range of 3-5 ft. The longitudinal section of the channel shows that the head reach was constructed by cutting local soils whereas middle and tail reaches were constructed in filling of local soil. A typical photograph of excessive silt deposition of UJC is shown as Fig. 1. The channel was found widened oddly in tail reaches and became nonoperational at design discharge.

Fig. 1. Excessive silt deposition at 109.73 km of UJC

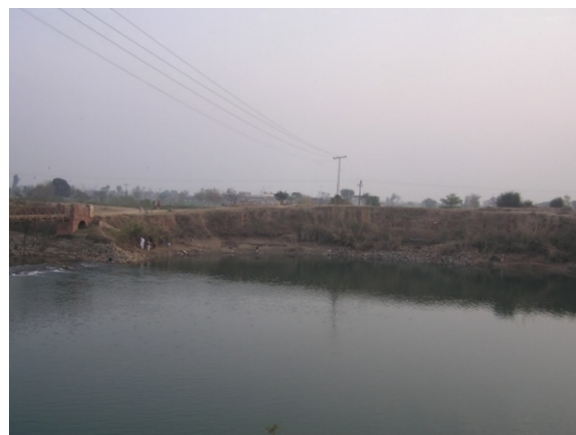
The banks of the channel were found eroded in several reaches throughout the channel and especially in the tail reaches. Apparently banks seem to be made of local soils having less cohesive particles. Excessive bank erosions have also caused excessive water losses,

less efficiency of canal system and canal breaches. The erosion of banks is also one of the problems which do not allow the canal to be operated at its design discharge. Figure 2 shows erosion of banks at typical location of UJC.

Fig. 2. Erosion of banks downstream at 99.02 km of UJC

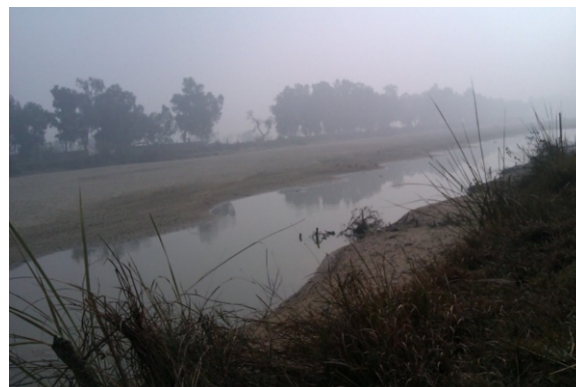
During condition survey, the water marks on the banks confirmed that recommended freeboard of 3 ft was not available in some reaches of the channel because of bank erosion, weather action, less maintenance and widened sections. It resulted in canal operation at lesser discharges compared with the design discharge. The canal has been run at even less than 50% of its design discharge since last 10 years. The freeboard was also found short at the upstream of some hydraulic structures. Fig. 3 depicts typical inadequate freeboard of UJC.

Fig. 3. Inadequate freeboard at 97.61 km of UJC

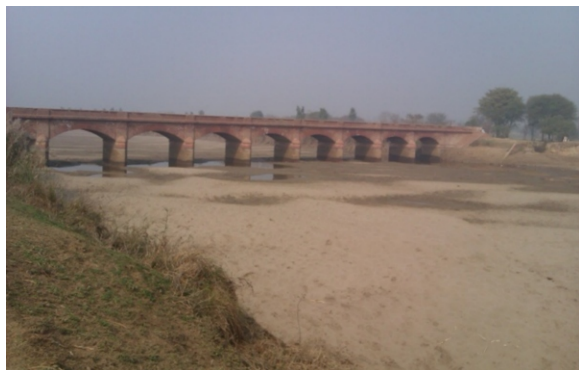
The side embayment was observed at downstream of hydraulic structures of Upper Jhelum Canal. The channel was constructed by fluming the channel width at hydraulic structure to reduce the construction cost. The transition provided for divergence and

convergence of flowing water at downstream and upstream was found unproductive. The Fig. 4 shows the excessive side embayment and widened section of UJC resulting in non operation at its required design discharge. The currents generated downstream of these structures traveled long distances along the canal before merging into normal depth of streamline flow. The undulating flow pattern generated channel instability and side embayment.

Fig. 4. Side Embayment and Widened section at 97.61 km of UJC

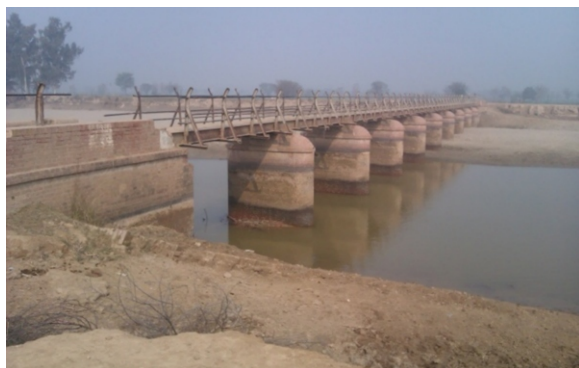
The channel has more than 100 hydraulic structures including bridges, falls, level crossings, siphons, cross-regulators and head regulators of offtaking channels. Most of the hydraulic structures are as old as the canal. Silt deposition was found on the upstream (u/s) and downstream (d/s) floors of the structures. Apparently the hydraulic performance of the structures was found satisfactory. However, the superstructures including deck slab of some hydraulic structures need repair and replacement. The trend of energy dissipation arrangement of the hydraulic structures was found effective as no scouring of bed and major side embayment were observed at their downstream. As such, the present condition of piers and foundations was found satisfactory. The water marks on piers shows that 2 - 3 ft free board is available near the hydraulic structures.

Fig. 5. Damaged Deck Slab and parapet of bridge at 122.6 km of UJC
