*3<sup>rd</sup> International Conference on Advances in Civil and Environmental Engineering (ICACEE-2024)*

## **Study of River Chenab Morphology Upstream Panjnad Barrage**

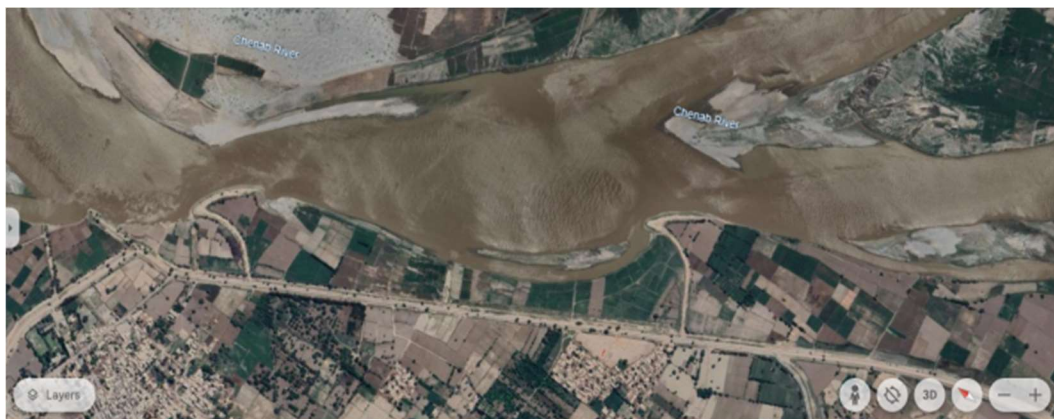
Figure 4(a,b) illustrates that the River reaches from RD 36+000 to 50+000 along the RMB U/S of the barrage and witnesses the flow of the Chenab's primary current. However, this specific stretch confronts a threat of erosion along the RMB and the accompanying structures, such as spurs. These spurs, erected with the explicit purpose of safeguarding public infrastructure and the Right RMB, face vulnerability due to the force and direction of the river's flow. The multifaceted nature of these observations underscores the complex and intertwined relationship between the

*Figure 4: (a) Vulnerable Reach RD36-50, (b) Erosion along Chenab right bank*

Figures 4(a,b) provide visual representations of the vulnerable reach RD 36+000 to 50+000 U/S of the barrage, illustrating the flow of the Chenab's main current. Despite the protective measures implemented, this stretch faces a persistent risk of erosion along the RMB and associated structures, such as spurs. The vulnerability arises from the force and direction of the river's flow, impacting the effectiveness of protective spurs. The complexity of these observations emphasizes the intricate relationship between river flow patterns, the functionality of the barrage, and the ecological impact on the surrounding areas. To effectively address these complexities and ensure infrastructure sustainability, a deeper understanding is required.

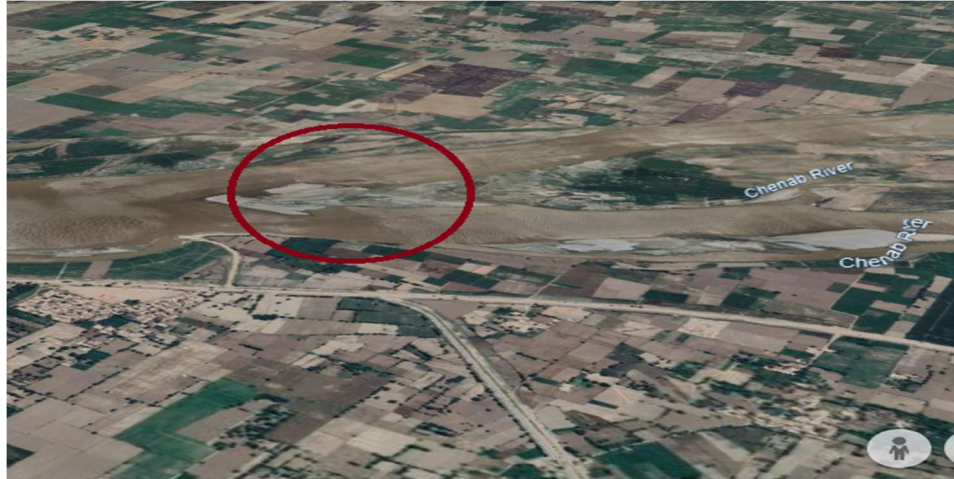
Figure 5 illustrates that the river Chenab main stream is divided into two sub-streams at RD 36+700 RMB (U/S) PJD Barrage. These two sub-streams approach Barrage separately and join each other at RD:3+000 U/S PJD. After the joining of sub-streams, a main-stream is developed which approaches the main weir in front of Bay No.1-12. The right-side sub-stream flows along RMB towards Barrage and the other one flows on the left side parallel to LMB.

The river Sutluj joins the river Chenab in this left side sub-stream about 15 km (Google Earth) U/S main weir. A permanent island has developed in between to above narrated sub-streams from the starting point to the Barrage due to less supply of water on the Barrage around the year. This island spreads from bay No.13-50 just 800 ft (field measurement) far from the weir on the U/S side. Due to island formation the efficiency and flood passing capacity of the Barrage is reduced.

Figure 5: Sub-streams formation at RD 36+700 RMB (source: Google Earth)

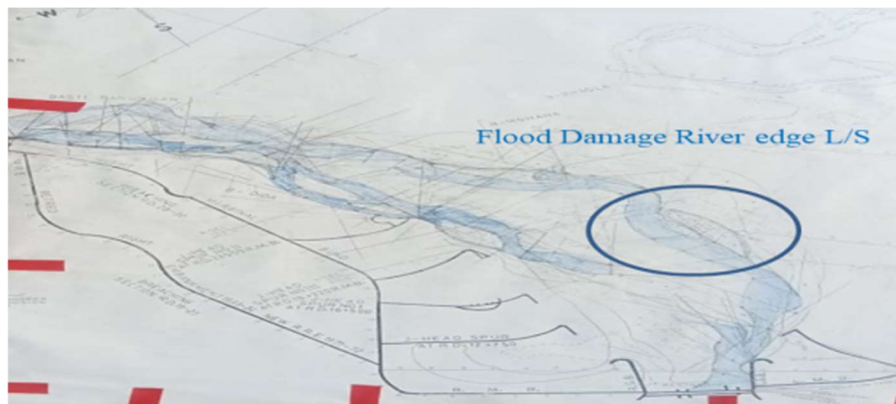
Figure 6: (a) Actual sheet plane table survey, and (b) confluence point river Satluj (source: Google Earth)

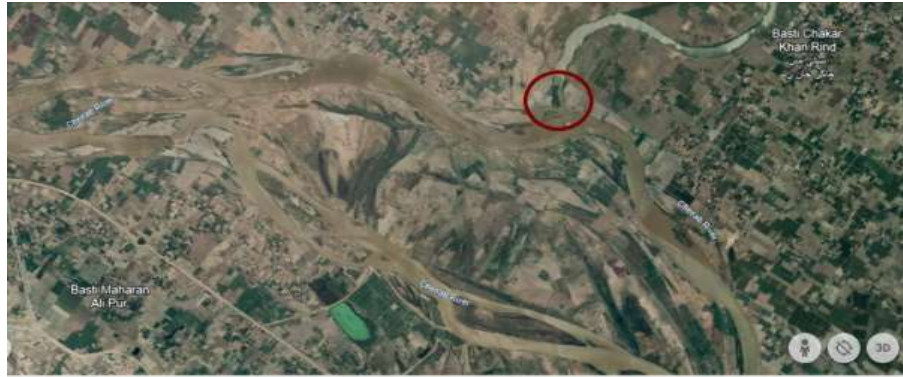
(b)

Figure 6 (a,b) illustrates that the confluence of the Chenab and Sutlej rivers. An event occurring approximately 15 km U/S of the barrage, proved momentous during the recent flood season of 2023. A staggering discharge of 151904 Cs (source: Punjnad Barrage Irrigation Punjab) at Islam Headworks from the River Sutlej into the left stream of the Chenab led to severe erosion and substantial damage, spanning an 800ft (field measurement) width along the LMB U/S of the barrage. This damage extended from the confluence point to the termination at J-Head Spur at Rd:5+500 along LMB, illustrating the sheer force and devastating impact of such discharge variations. The bifurcation of these primary streams at RD:36+000 U/S of the barrage had lasting implications, contributing to the permanent formation of an island or Bela between these streams, persisting steadfastly from their inception until their eventual stage. This distinct divergence of streams significantly influences the river's morphological behavior [6,8], highlighting the intricate interplay between natural forces and the evolving course of the river.

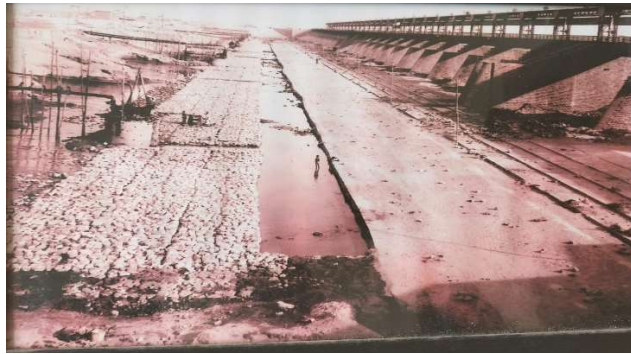
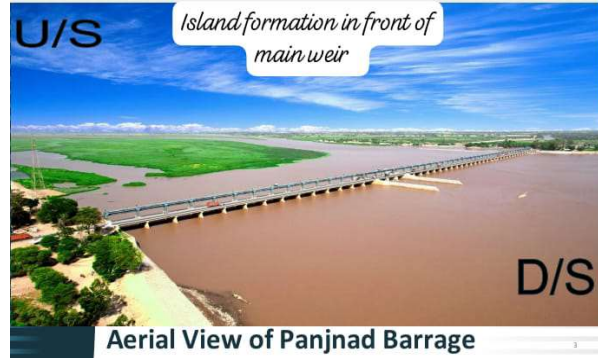
Figure 7 (a,b) illustrates that river Chenab comes to the barrage with two main streams, and these streams start from RD35+000 U/S RMB and join just 2000ft U/S (field measurement) main weir. This supply exhibits inconsistency throughout the year, which is primarily allocated for canal off-takes. Consequently, to maintain the U/S pond level, a necessary action to manage the varying supply, the barrage gates must remain closed, emphasizing the challenges posed by the fluctuating river supply. The consequences of this fluctuation in supply manifest significantly in the emergence of islands or Belas in front of the main weir, specifically between gates no 13-50, positioned a mere 800ft(field measurement) U/S of the main weir. This Bela formation intensifies challenges during flood seasons, notably reducing the barrage's passage capacity and disrupting the smooth flow of the river's main current toward the barrage. This critical scenario emphasizes the complex impact of the river's varying supply on the barrage's operational efficiency and its ability to effectively manage floodwaters [4,5].

Figure 7: (a) Old picture of Panjnad barrage main weir 1932, and (b) drone camera (source: Irrigation department)
