## **Performance Evaluation of Pre-Damaged Fire Effected Deep Beams**

### **3<sup>rd</sup> International Conference on Advances in Civil and Environmental Engineering (ICACEE-2024)**

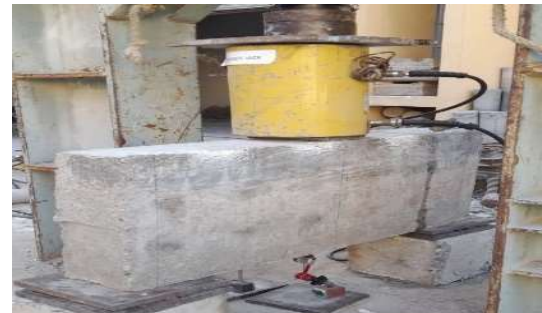
*Figure 2: Testing Setup*

As shown in Figure 2, the simply supported deep beams underwent a three-point load test. The load is applied in the centre of beam at 530 mm from support by a 140 mm wide load plate. The support is arranged such that the centre of assembly aligns at a distance 150mm from both the supports so that edges of beam may not be crushed under the loading. A 2000-tone jeck was used to apply gradual load under displacement control.

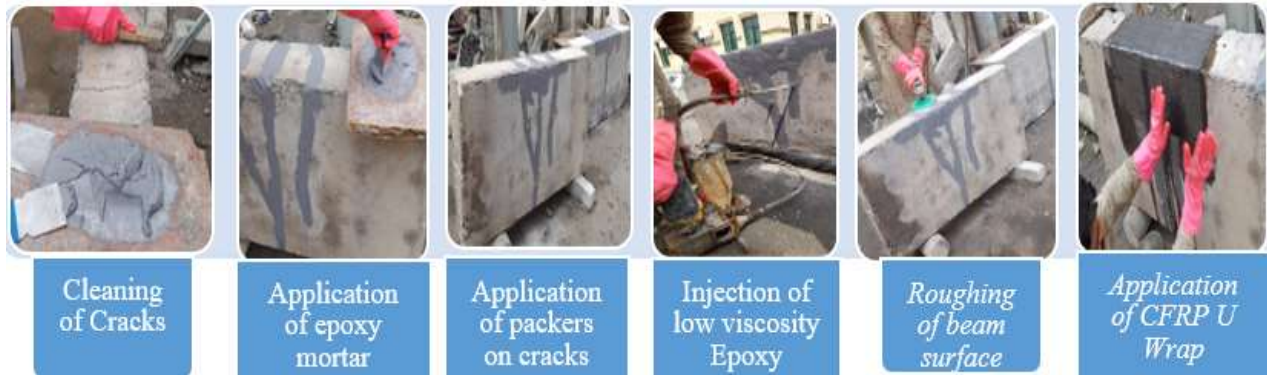
Figure 4: Retrofitting Process

The surfaces were then cleaned to get rid of any dust or contaminants. A unidirectional CFRP longitudinal strip was added on deep beam's soffit in spans to increase the beam's flexural capacity and prevent flexural failure. A U-wrap consisting of a single layer of a unidirectional CFRP sheet was placed, with the fibers oriented longitudinally. The exterior surface of the concrete was coated with an epoxy primer coating to seal any gaps in the surface and establish a robust connection between the concrete and CFRP strip. The strengthening process is shown in figure 4.
