# TECHNICAL JOURNAL

**Volume No. 18  
No. 1 (Jan - June)  
2013**

## Cases of Slope Failure of Irrigation And Drainage Channels In Egypt and Their Rehabilitation

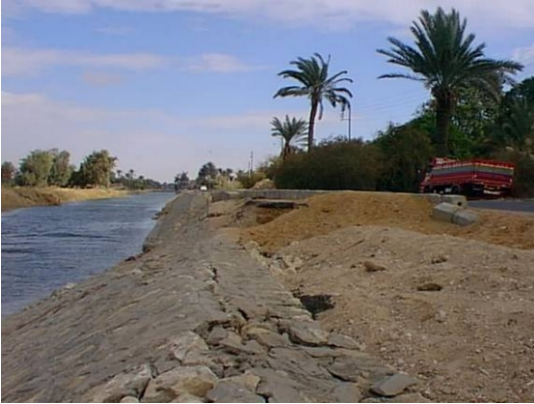
Figure 4 : Slope failure of case 1

In this case, when examining the site history and condition, it was found that a main road was constructed on the left embankment of the canal to allow heavy traffic loads to pass along it. The construction process included completing the embankment width and reshaping the side slope to its original slope 2:1 and then put riprap to protect it. It was also known that a bomb hit the site during 1973 war. Consequently, the site investigation was directed to investigate the presence of a camouflets which is an underground cavity formed by the explosion of a bomb without the formation of a crater (British Standards Institution, 1957). Not finding any cavity, a slope stability study of the left embankment was conducted. An equivalent load of a 60-ton lorry and the case of sudden draw down of the water level in the canal were considered. The critical factor of safety was almost 1.0 and the sliding circle lied inside the loose surface soil layer. This value of the factor of safety is low and explains the repeated failure of the left embankment and the riprap on the side slopes. When using a slope of 2.5:1 and the properties of dense soil in the stability analysis, the critical factor of safety became 1.48, which is accepted according to the Egyptian code. Hence, it was concluded that the explosion at the site caused the top sandy soil to loosen along the failing 100.0 m reach. Then, after constructing the main road, the loose nature of the top soil layer could not stand the new heavy traffic loads causing the repeated slope failures. Figure 4 shows the slope failure of the embankment.

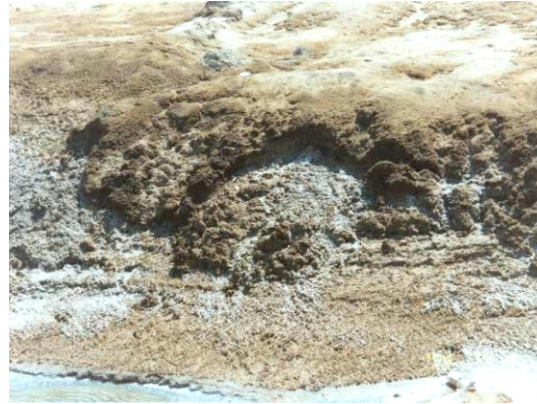
Figure 5 : Salt leaching and slope failure of case 2

Stability analysis of the slopes of the channel and drain was carried out to identify the main cause of the slope failure. This study was carried out under different boundary conditions such as with and without seepage effect, with and without sudden draw down of the water level in the channel, and with and without live load on the embankment. In all cases, the factor of safety achieved the requirements of the Egyptian code of practice. Therefore, the existing slope failure cannot be attributed to any of the above-mentioned conditions. Looking at the laboratory test results, it was noted that the chemical analysis of the soil samples showed the presence of a high percentage of dissolved salts. Hence, the attention was drawn to the results of the chemical analysis of the soil and the water and it was concluded that the failure occurred because of the leaching effect of the high salt concentration within the soil particles and consequently initiating the piping phenomenon (internal erosion). Figure 5 shows salt traces due to leaching at the drain side slopes. The developed seepage forces started the fine particles washing (migration) and that in turn reduced the stability of the drain side slopes and consequently causing the slope failure of the drain. Furthermore, the continuing process of internal erosion created cavities within the soil mass between the canal and drain causing collapse of parts of the embankment surface and parts of the gabions on the canal side slopes. Field observations supported the above-mentioned conclusion of the cause of failure.

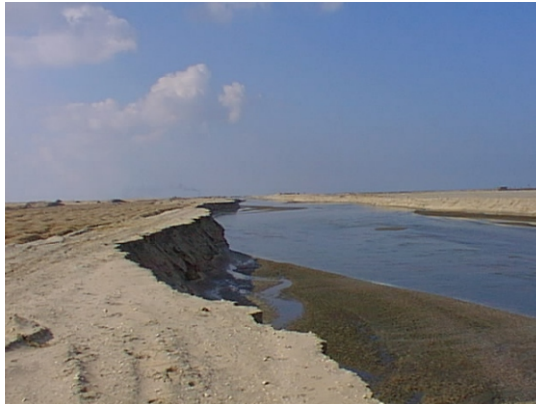
Figure 6 : Slope failure of case 3

A slope stability analysis was carried out using a computer program. In the beginning, the stability of the slopes on the dry condition was examined and the factor of safety was 1.1, which shows that the slope does not satisfy the requirements of the Egyptian code of practice. Then, additional runs were carried out with seepage forces and live loads and the factor of safety was 0.96. The failure of such case can be attributed to two main causes, the first one is the instability of the slope due to the gravitational effect and the seepage forces, which cause the fine particles to

migrate causing internal erosion. The second one is due to the high velocity of the flowing water that causes surface erosion either from the side slopes and/or the bed of the drain especially near the suction basin of the pump station.

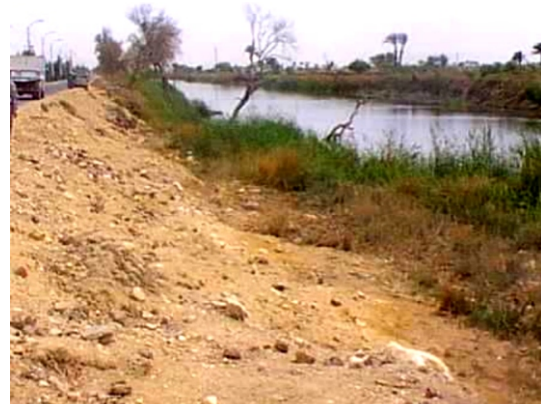
Figure 7 : Slope failure of case 4

Figure 7 shows the failure of the canal side slopes. A slope stability analysis was carried out to determine the probable causes of failure. Noting that the failures occurred after the winter closure, a sudden draw down of the water level was considered in the analysis. Also, the case where the seepage line is from the existing drain to the canal was studied. In both cases, equivalent loads of 60-ton lorry have been taken into consideration since heavy traffic loads were allowed on the road on the canal embankment. The factor of safety of the normal working conditions (without heavy traffic loads and sudden draw down) is 1.50, which is safe according to the Egyptian code of practice. While the minimum factor of safety was 0.70 in the case of sudden draw down and heavy traffic loads. Therefore, it was concluded that the sudden draw down combined with the heavier traffic loads caused the slope failure of the canal.

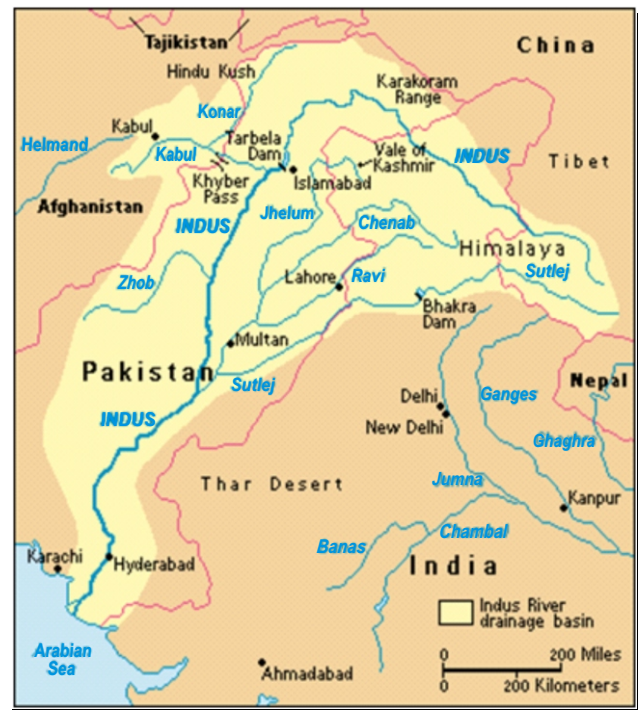
Figure 1 : Expanse of the Indus basin  
(Source: <http://www.rifah.org/site/the-indus-accord-1960>)

The Indus Valley is one of the most advanced ancient civilizations. It is also called cradle of civilizations owing to its substantial fertile land resources, waters of mighty Indus river system and favorable agro-climatic potential. The valley is segmental homogeneous with plain extending from foot hills of Himalayas to the coast of Arabian Sea, bounded on the west by Kirthar and Suleiman mountains ranges, on the east by Punjab plains up to Ambala and Kalka in India whereas low lying ridges divide it from the plains of Yamuna River. Length of Indus plains from Himalayan piedmont to Arabian Sea is more than 1500 km whereas its width in Punjab is up to 325 km. Expanse of the Indus Basin is shown in Figure 1. Almost 53 percent of the basin area lies in Pakistan. Indus basin is geographically divided into doabas, the land between two adjacent rivers, and each doaba derives its name from the bounding rivers. The initial agriculture in the plains commenced in about 3000 BC (Fahlbusch *et al.*, 2004). Inundation canals were traditional practices for managing irrigated agriculture. Modernization and expansion of irrigation system however commenced in the British era in the middle of the last century. It is now one of the world's marvelous and the largest contiguous irrigation system.

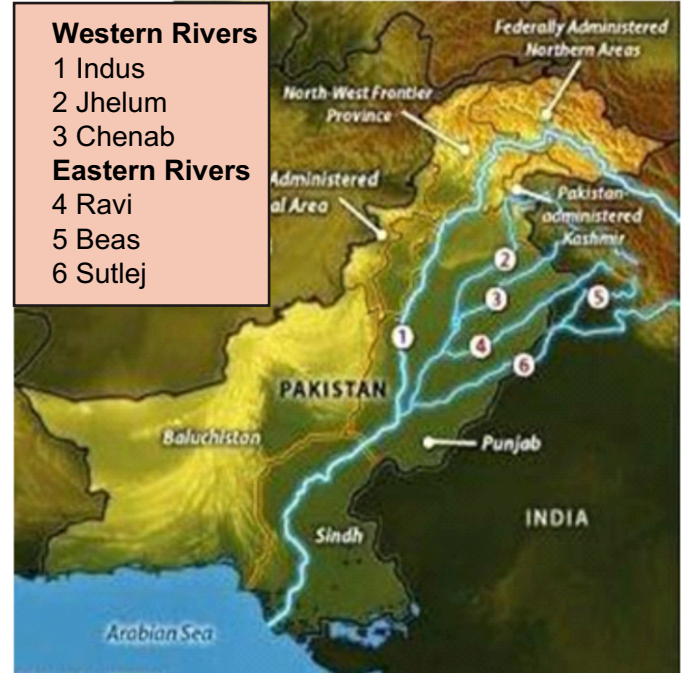
Figure 2: The Indus River system showing western and eastern rivers

- iii. Pakistan shall receive unrestricted use of all the waters of the western rivers (Indus Jhelum and Chenab, Figure 2). India shall be under an obligation to let flow all the waters of the Western rivers, and shall not permit any interference with these waters (World Bank, 1960).

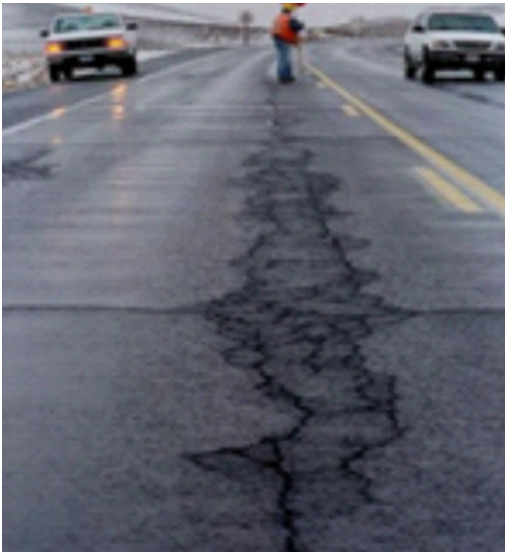
Figure 1 : Fatigue cracking due to stripping in asphalt pavement

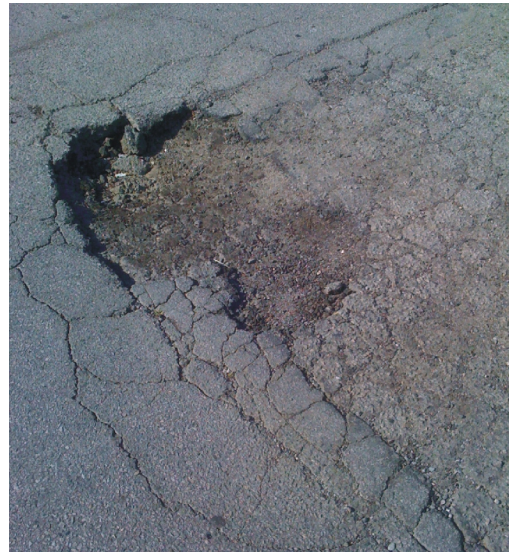
Figure 2 : Stripping in asphalt pavement due to lack of bond b/w asphalt and aggregate

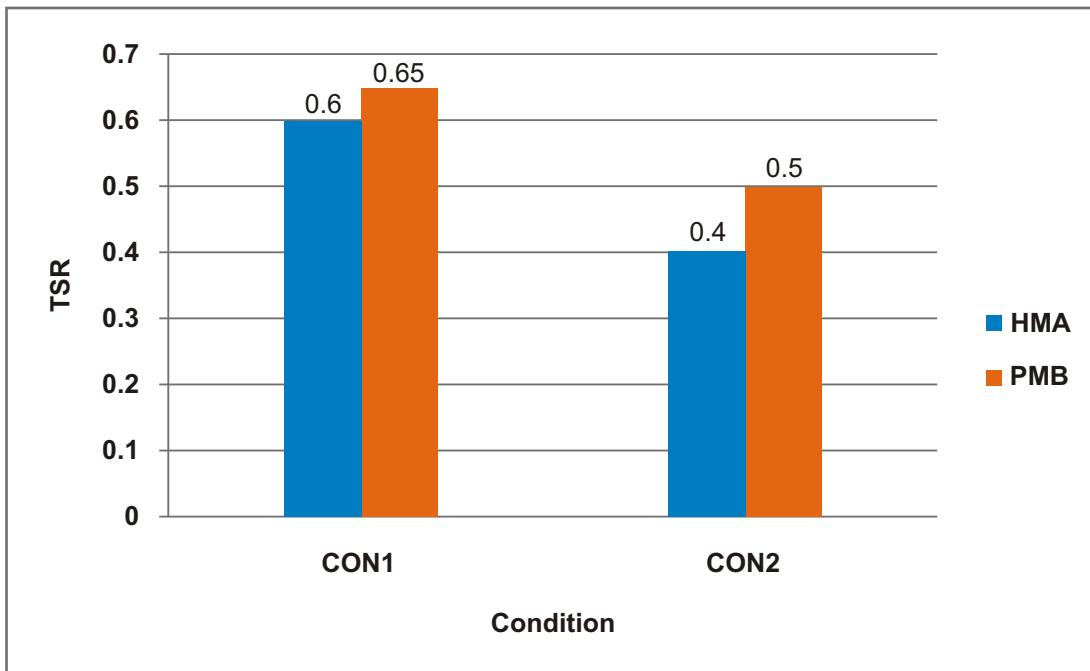
Figure 5 : Comparison of TSR of HMA and PMB

The tensile strength ratio (TSR) was calculated by dividing the average tensile strength of the conditioned samples by the average tensile strength of the unconditioned control samples, 80 percent TSR is normally required for the mixes to be resistance against moisture damage.

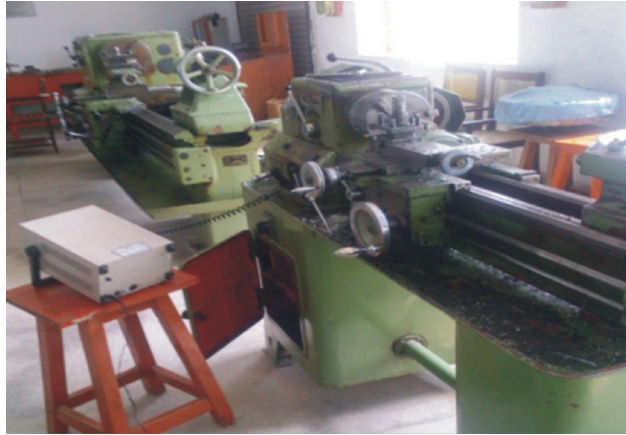
Figure 1 : Experimental setup on BI115

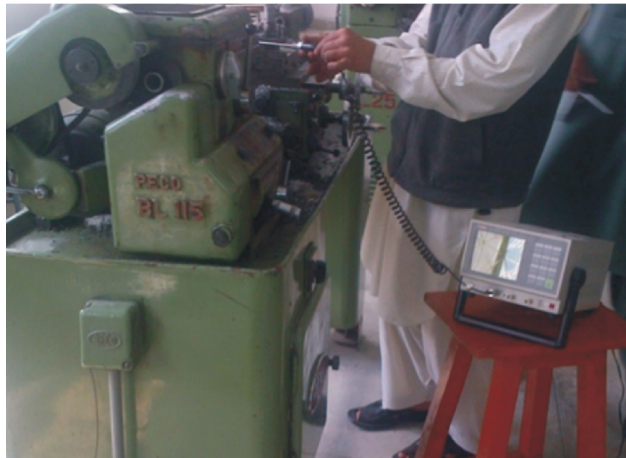
Figure 2 : Experimentation and readings with vibration meter

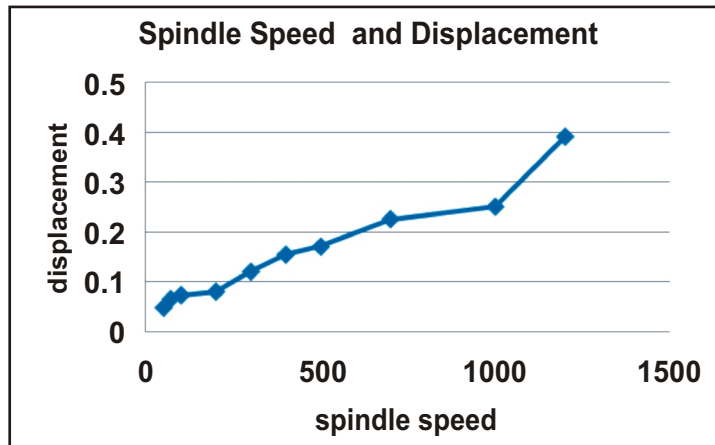
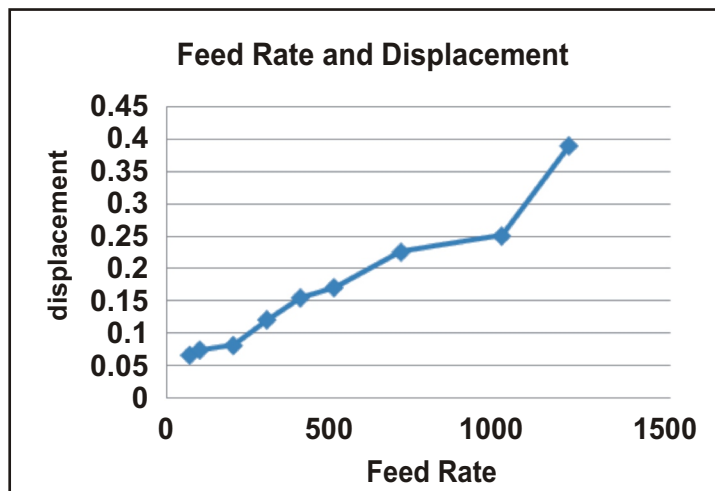
Figure 3 & 4 clearly shows that the displacement in vibration amplitude increase as the feed rate and spindle speed is increased.

Figure 3 : Displacement and spindle speed of simple cutting tool

Figure 4 : Feed rate and displacement of simple cutting tool

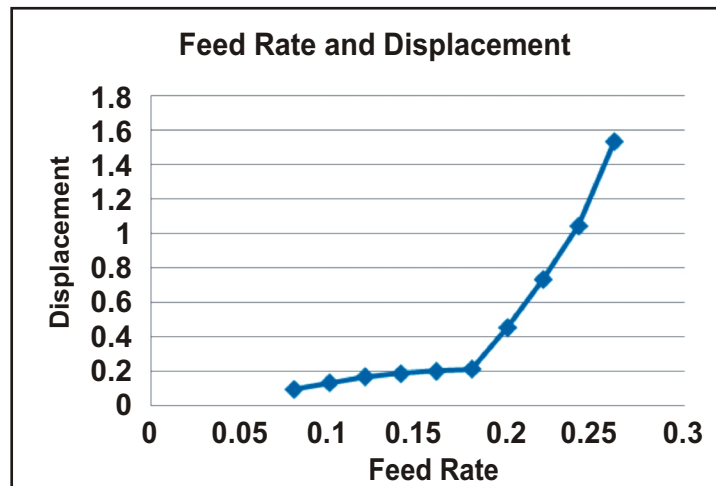
The trend shown in Figure 5 & 6 clearly showing that a decrease in displacement occurs if we use piezoelectric material 5A ring of 1 inch, displacement increases as feed rate and spindle speed increases.

Figure 5 : Displacement and feed rate with pzt

Figure 6 : Displacement and spindle speed with pzt

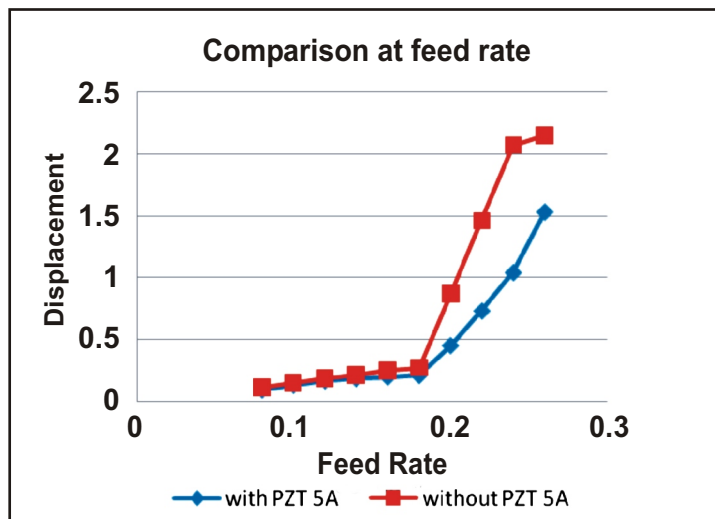
The comparison between both turning cutting tool vibrations at feed rate and spindle speed without and with piezo material are indicated in Figure 7 and comparative less displacement has been found in case of piezo attachment.

Figure 7 : Comparison between with and without pzt cutting tool at feed rate
