# TECHNICAL JOURNAL

**Volume No. 18  
No. 1 (Jan - June)  
2013**

## **Cases of Slope Failure of Irrigation And Drainage Channels In Egypt and Their Rehabilitation**

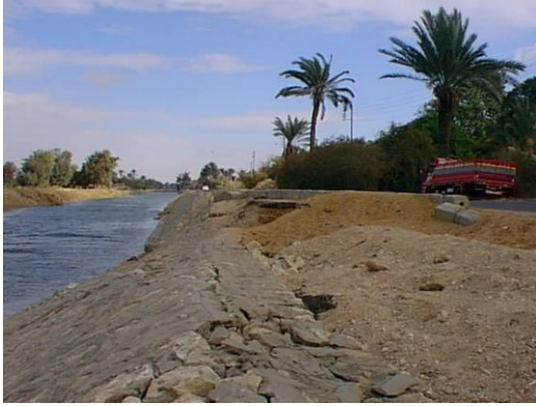
In this case, when examining the site history and condition, it was found that a main road was constructed on the left embankment of the canal to allow heavy traffic loads to pass along it. The construction process included completing the embankment width and reshaping the side slope to its original slope 2:1 and then put riprap to protect it. It was also known that a bomb hit the site during 1973 war. Consequently, the site investigation was directed to investigate the presence of a camouflets which is an underground cavity formed by the explosion of a bomb without the formation of a crater (British Standards Institution, 1957). Not finding any cavity, a slope stability study of the left embankment was conducted. An equivalent load of a 60-ton lorry and the case of sudden draw down of the water level in the canal were considered. The critical factor of safety was almost 1.0 and the sliding circle lied inside the loose surface soil layer. This value of the factor of safety is low and explains the repeated failure of the left embankment and the riprap on the side slopes. When using a slope of 2.5:1 and the properties of dense soil in the stability analysis, the critical factor of safety became 1.48, which is accepted according to the Egyptian code. Hence, it was concluded that the explosion at the site caused the top sandy soil to loosen along the failing 100.0 m reach. Then, after constructing the main road, the loose nature of the top soil layer could not stand the new heavy traffic loads causing the repeated slope failures. Figure 4 shows the slope failure of the embankment.

Figure 4 : Slope failure of case 1

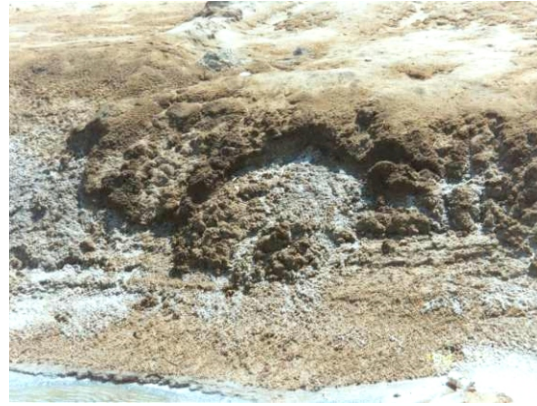
Figure 5 : Salt leaching and slope failure of case 2

Stability analysis of the slopes of the channel and drain was carried out to identify the main cause of the slope failure. This study was carried out under different boundary conditions such as with and without seepage effect, with and without sudden draw down of the water level in the channel, and with and without live load on the embankment. In all cases, the factor of safety achieved the requirements of the Egyptian code of practice. Therefore, the existing slope failure cannot be attributed to any of the above-mentioned conditions. Looking at the laboratory test results, it was noted that the chemical analysis of the soil samples showed the presence of a high percentage of dissolved salts. Hence, the attention was drawn to the results of the chemical analysis of the soil and the water and it was concluded that the failure occurred because of the leaching effect of the high salt concentration within the soil particles and consequently initiating the piping phenomenon (internal erosion). Figure 5 shows salt traces due to leaching at the drain side slopes. The developed seepage forces started the fine particles washing (migration) and that in turn reduced the stability of the drain side slopes and consequently causing the slope failure of the drain. Furthermore, the continuing process of internal erosion created cavities within the soil mass between the canal and drain causing collapse of parts of the embankment surface and parts of the gabions on the canal side slopes. Field observations supported the above-mentioned conclusion of the cause of failure.

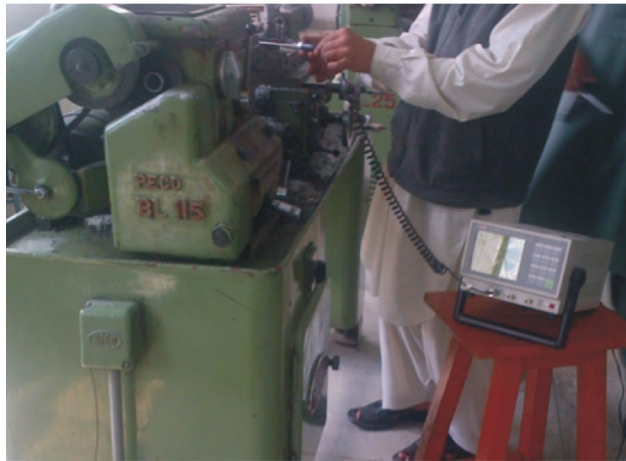
Figure 2 : Experimentation and readings with vibration meter

are calculated from vibration meter. Values are collected and tabulated in Table 1 & 2 for displacement at various feed rate and spindle speed.
